GEOTECHNICAL REPORT**ADOT Project No. 377 NA 008 F0661 01D****Federal Reference Project No. FA-377-A(203)T****MP8 - Phoenix Park Wash, S of Dry Lake**

Subject:
Geotechnical Report
MP8 - Phoenix Park Wash, S of Dry Lake
ADOT Project No. 377 NA 008 F0661 01D

This report presents the results of our geotechnical engineering services to support the construction of the shoulder widening on State Route 377 (SR-377) at mileposts (MP) 8 to MP 13. The project is located north of the community of Heber-Overgaard within the Arizona Department of Transportation (ADOT) Northeast District.

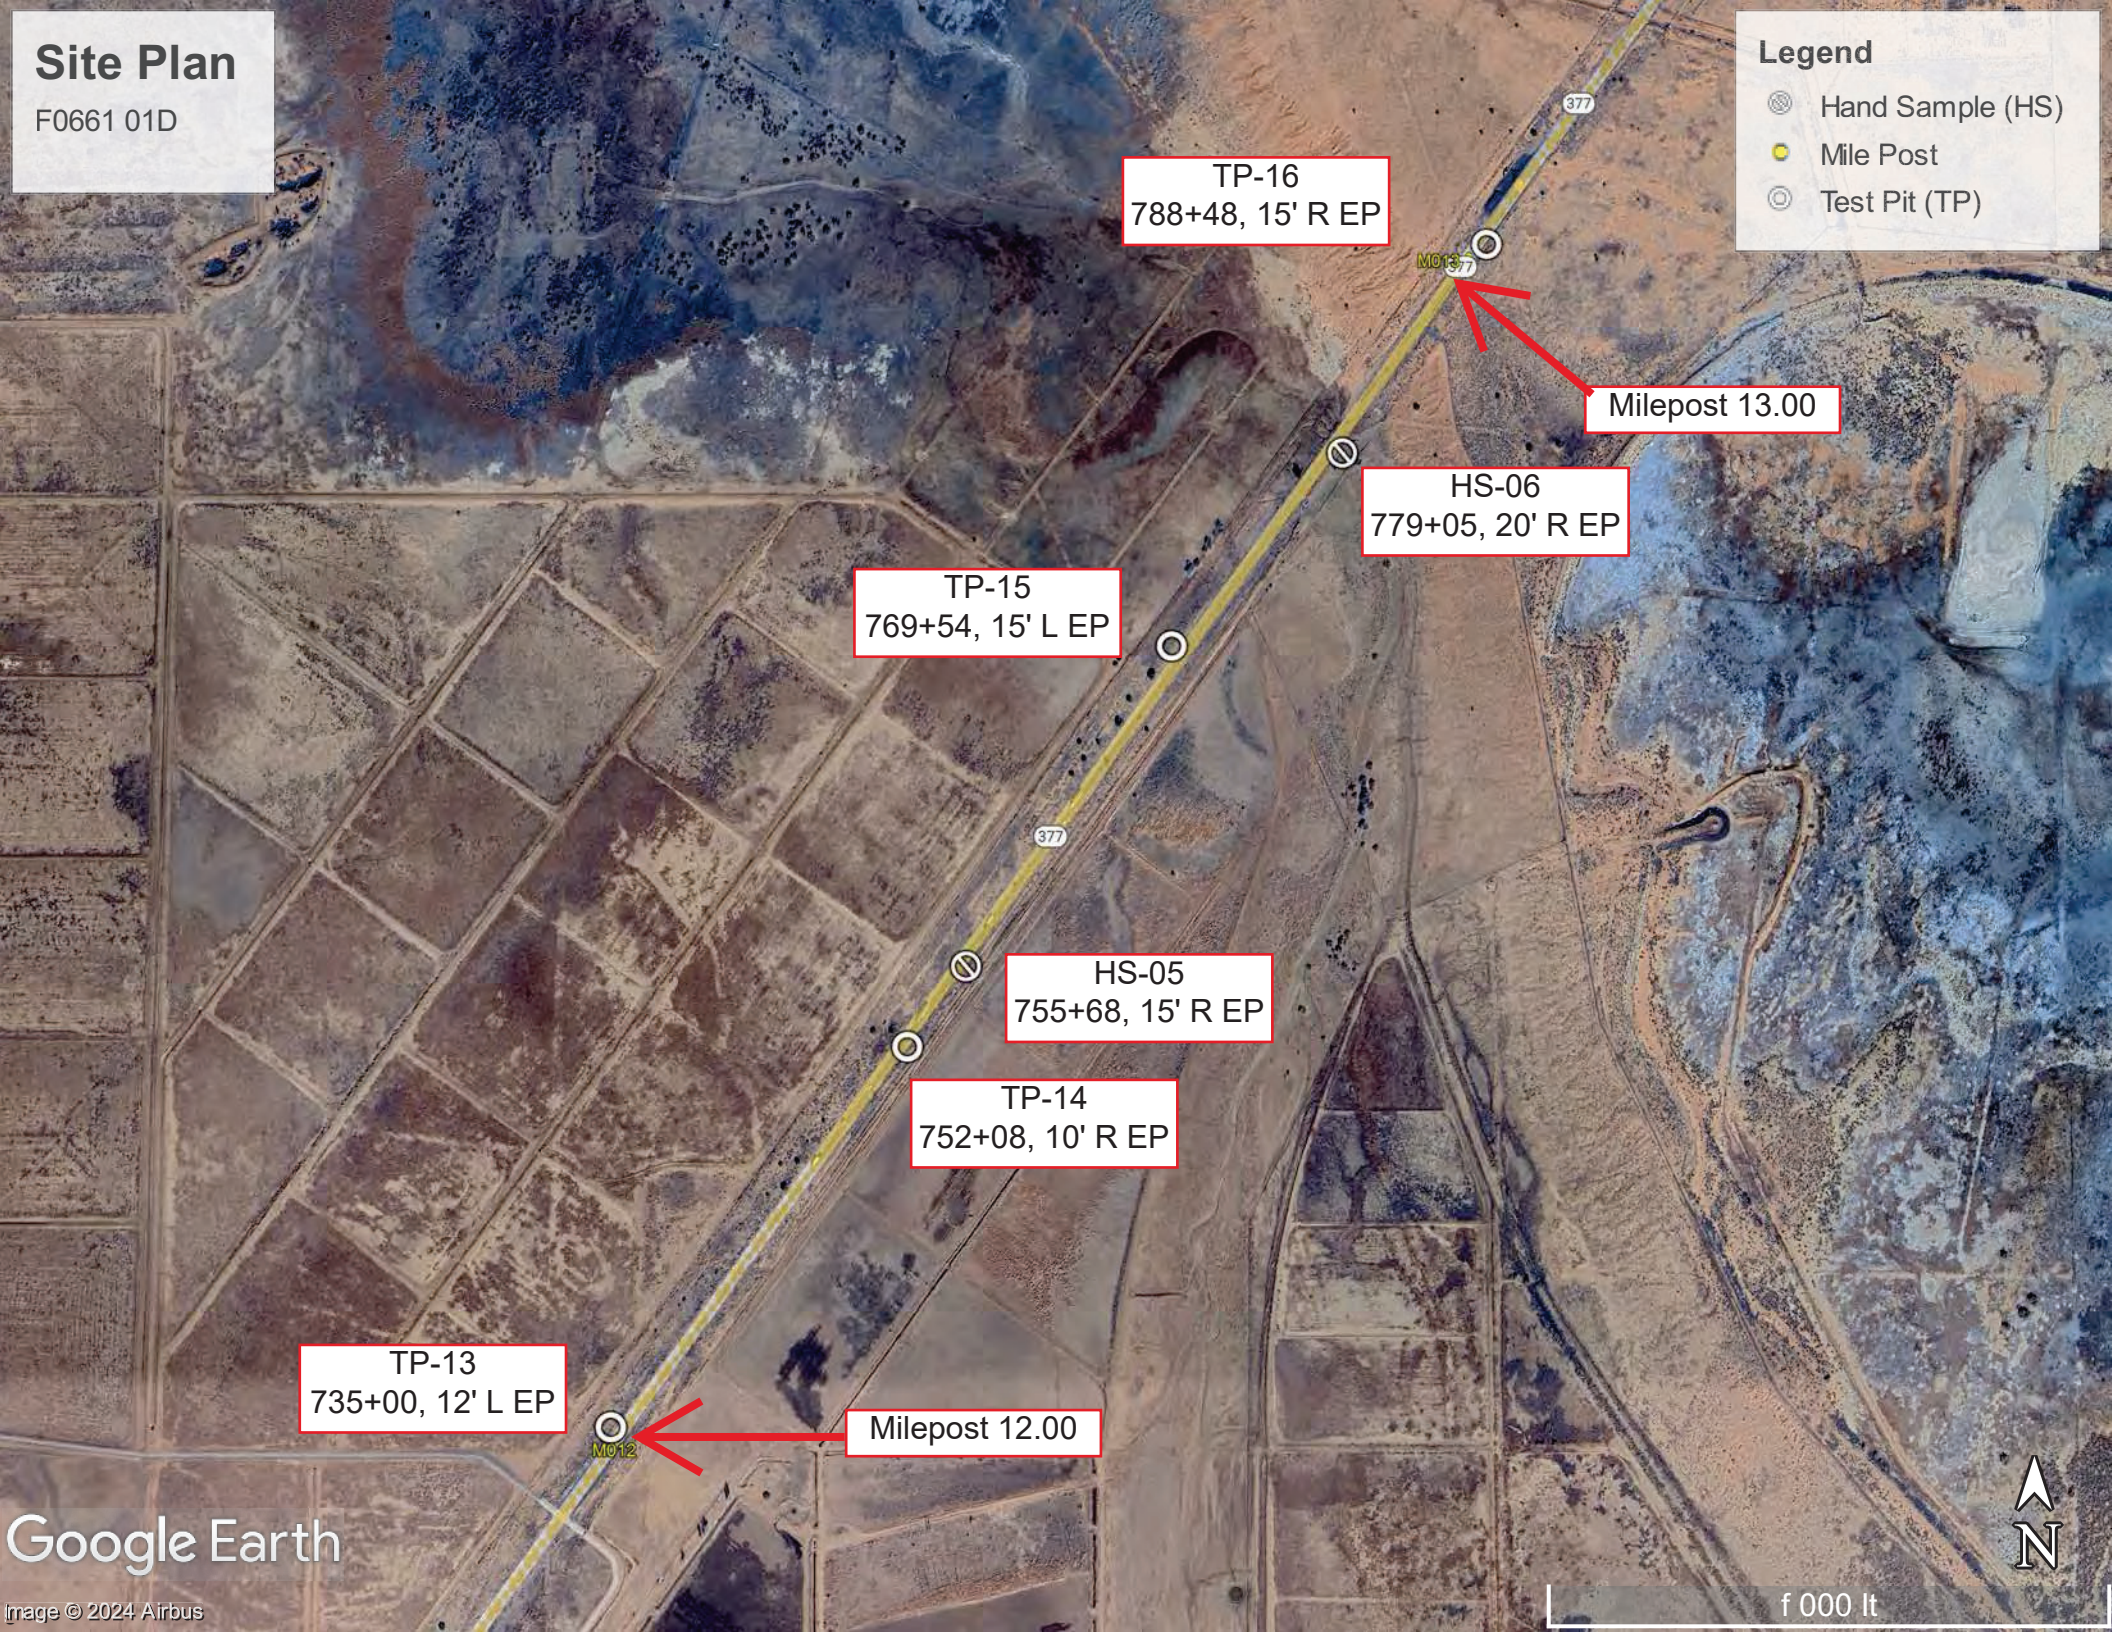
Site Plan

TP-12
716+76, 5' R EP

HS-04
710+40, 12' R EP

TP-11
699+29, 5' L EP

HS-03
688+12, 6' R EP

TP-10
682+03, 10' R EP

The test pits were located in the field using a hand-held, global positioning system (GPS) instrument in conjunction with Google Earth images, and project plans. A site plan showing the test pits are presented in Appendix A of this report. The test pit logs are presented in Appendix B of this report.

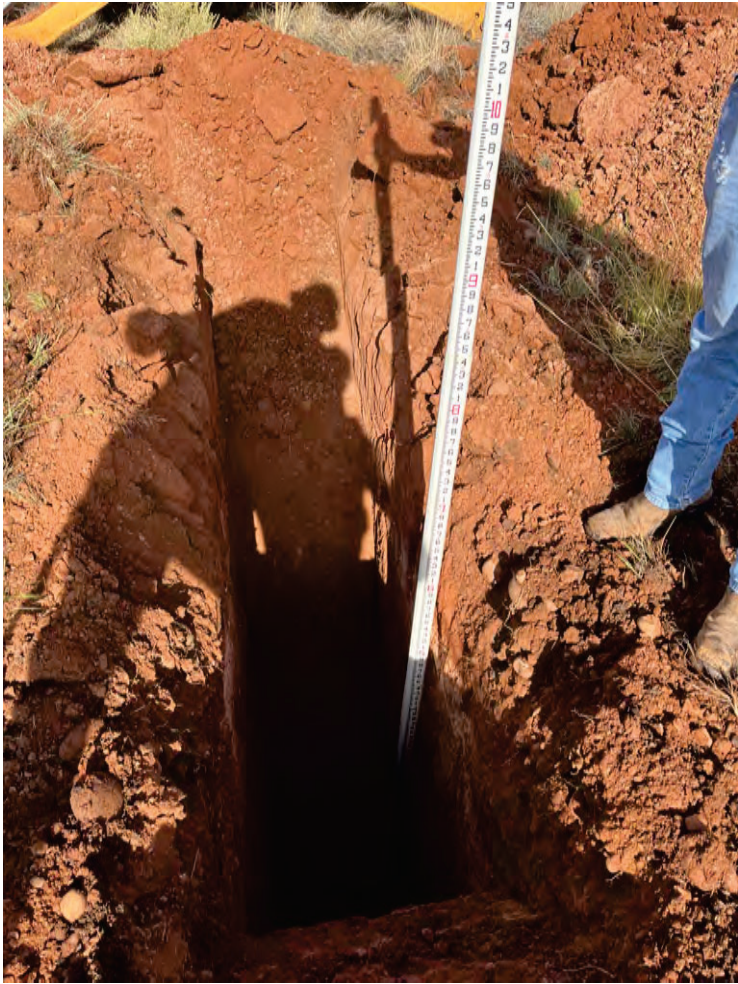
Bulk	SANDY LEAN CLAY (CL): brown; medium plasticity; no cementation; damp.	4	32	64	27-15-12
2								
3								
4								
5

Stopped test pit excavation at 5'. No groundwater encountered in test pit.

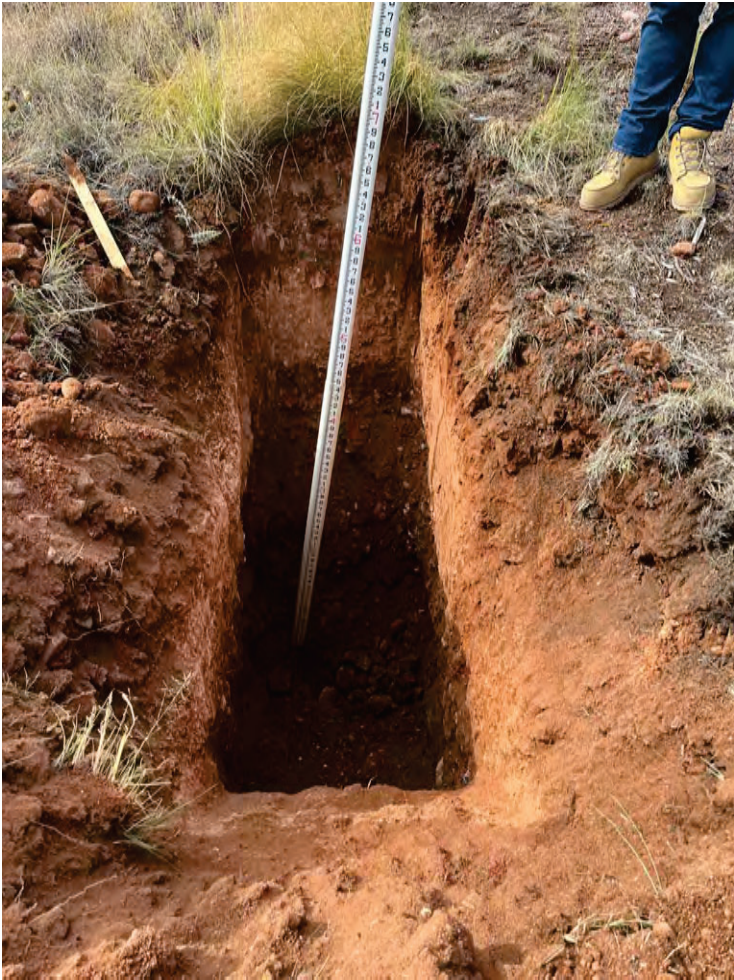
Bulk	CLAYEY SAND WITH GRAVEL (SC): dark brown; medium plasticity; no cementation; damp.	40	43	17	32-15-17	6	103.8
2										
3										
4										
5

Stopped test pit excavation at 5'. No groundwater encountered in test pit.

In-place density and moisture tests were performed at the TP-02, TP-06, TP-09, TP-12, and TP-15 to compare the in-situ conditions versus the laboratory tested maximum dry density and optimum moisture results. The tests were performed using the nuclear density (ASTM D6938) method. The in-situ density test location and results are included in the Laboratory Testing Summary under Field Tests in Appendix C.

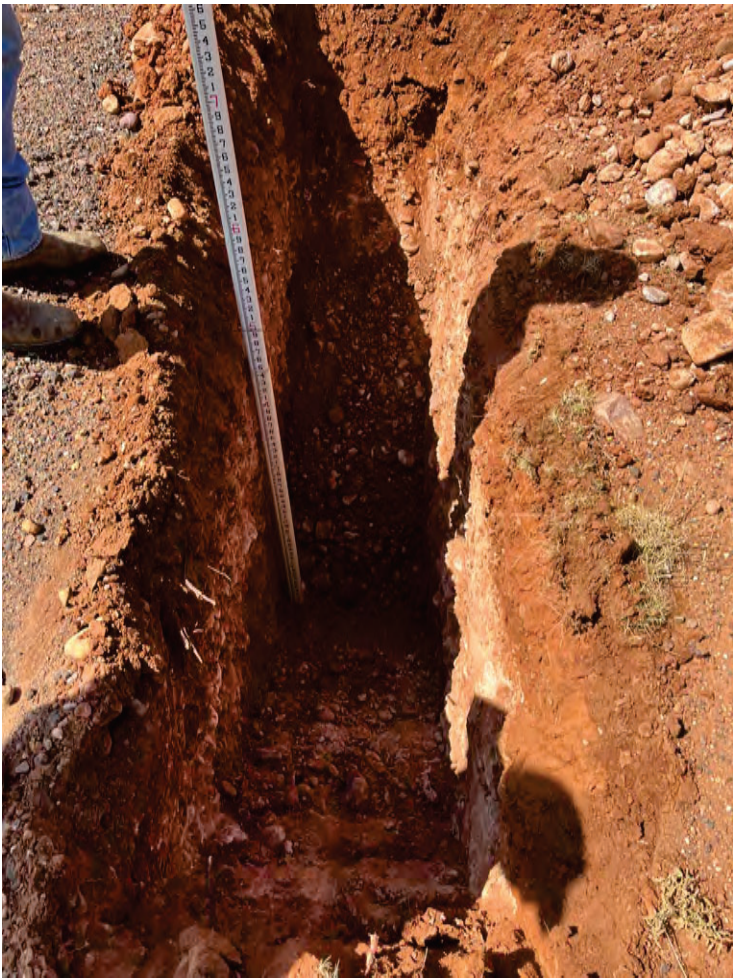
Bulk	POORLY GRADED GRAVEL WITH CLAY AND SAND (GP-GC): brown; high plasticity; weak cementation; slightly damp.	62	25	9	38-17-21
2								
3								
4								
5								
5.0

Stopped test pit excavation at 5'. No groundwater encountered in test pit.

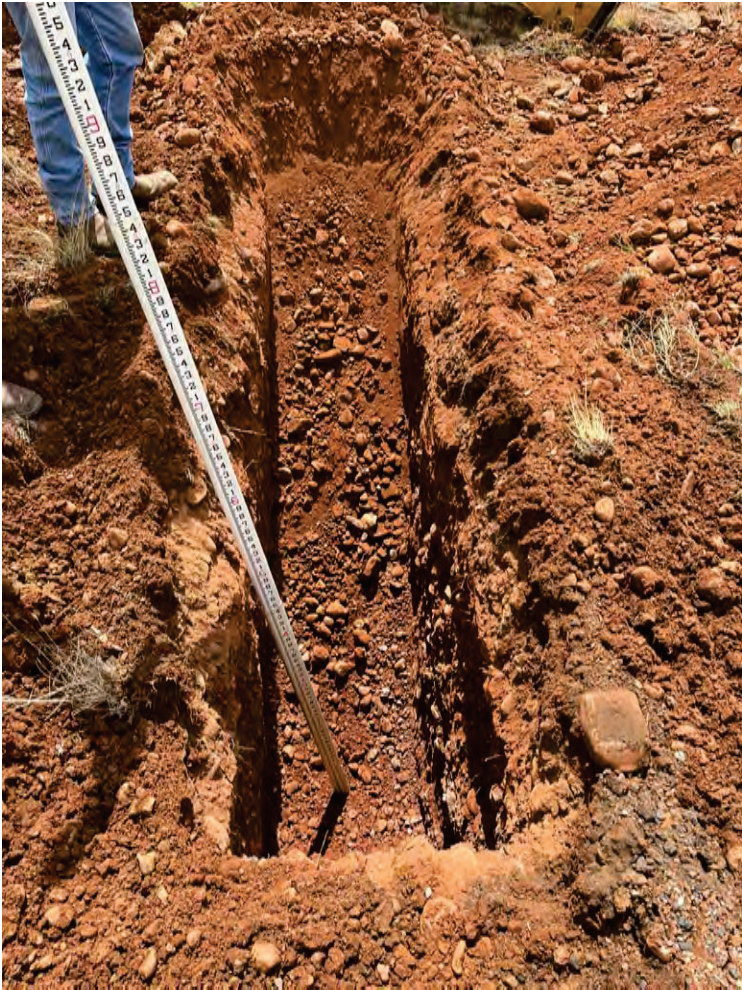
Bulk	POORLY GRADED GRAVEL WITH CLAY AND SAND (GP-GC): dark brown to brown; medium plasticity; no cementation; slightly damp.	64	26	10	33-16-17
2								
3								
4								
5

Stopped test pit excavation at 5'. No groundwater encountered in test pit.

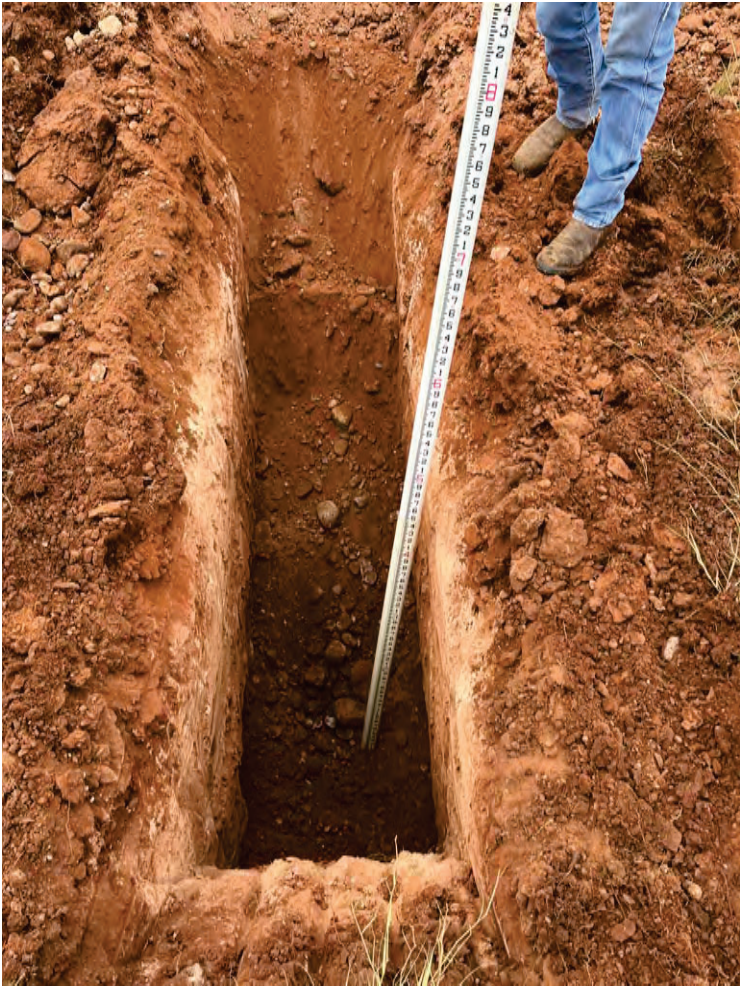
Bulk	SILTY SAND (SM): brown; non-plastic; no cementation; slightly damp.	7	65	28	NP
2								
3								
4								
5								
5.0

Stopped test pit excavation at 5'. No groundwater encountered in test pit.

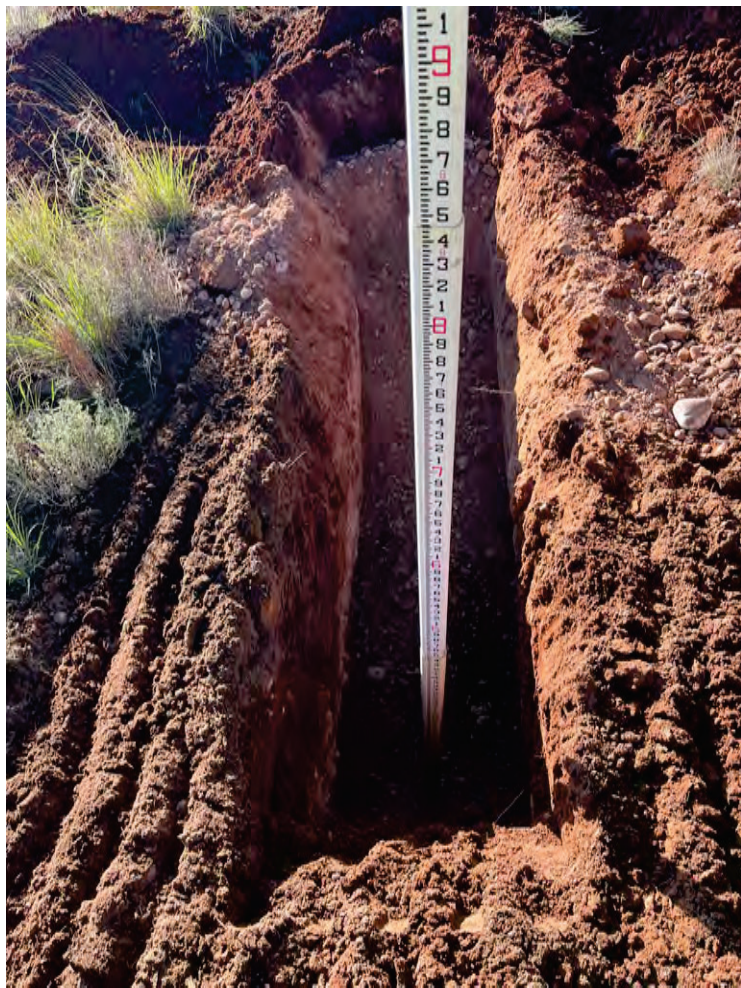
Project Name	Shoulder Improvements	Test Pit	
Project No.	377 008 F0661 01D		
Location	SR 377, MP 9.64	TP-06	
Station, Offset	610+26, 10' R EP		
Lat/Long, elev	34.58462, -110.40169 at 5920'		
Field Engineer	Omied Arianejad	Date	08/14/2024
Field Operator	ADOT Geotechnical Operations	Backhoe	CAT 420

Depth (ft)	Elevation (ft)	Graphic Log	Sample Type	Visual Classification	Lab				Samples	
					% Gravel	% Sand	% Fines	Atterberg Limits (LL-PL-P)	In-Situ Moisture Content (%)	In-Situ Dry Density (pcf)
1	5915		Bulk	CLAYEY SAND (SC): dark brown to brown; medium plasticity; no cementation; damp.	9	55	36	26-14-12	5.8	112.2
2			Bulk	WELL-GRADED GRAVEL WITH SILT AND SAND (GW-GM): light brown to tan; non-plastic; no cementation; slightly damp.	57	37	6	NP		
3										
4										
5

Stopped test pit excavation at 5'. No groundwater encountered in test pit.

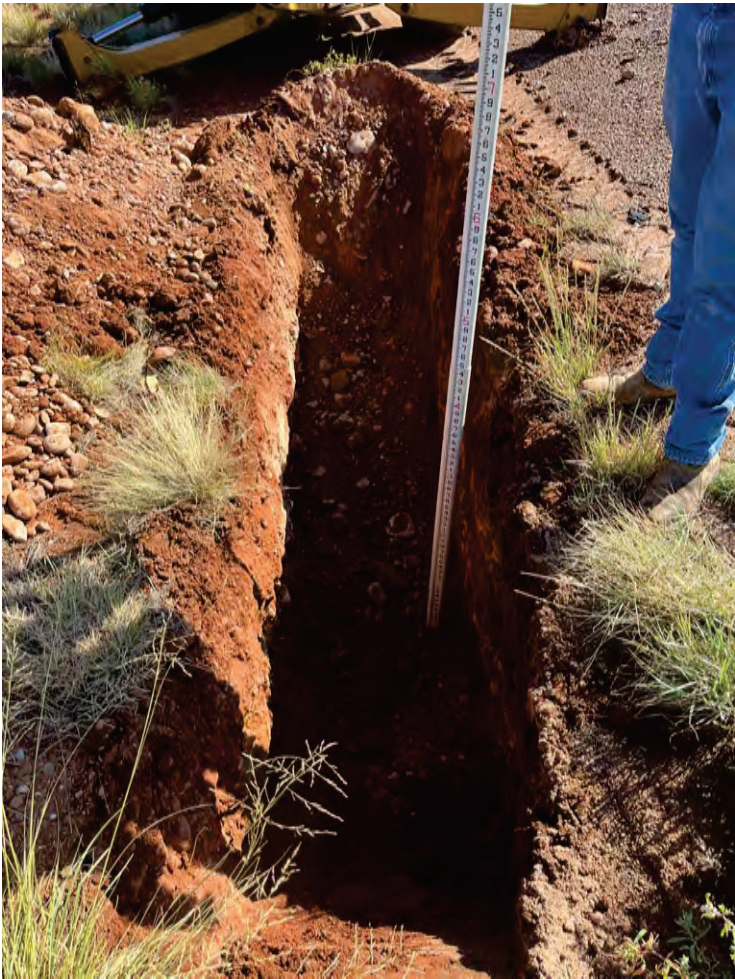
Bulk	POORLY GRADED GRAVEL WITH SILT AND SAND (GP-GM): brown; non-plastic; no cementation; slightly damp.	48	44	8	NP
2								
3								
4								
5								
5.0

Stopped test pit excavation at 5'. No groundwater encountered in test pit.

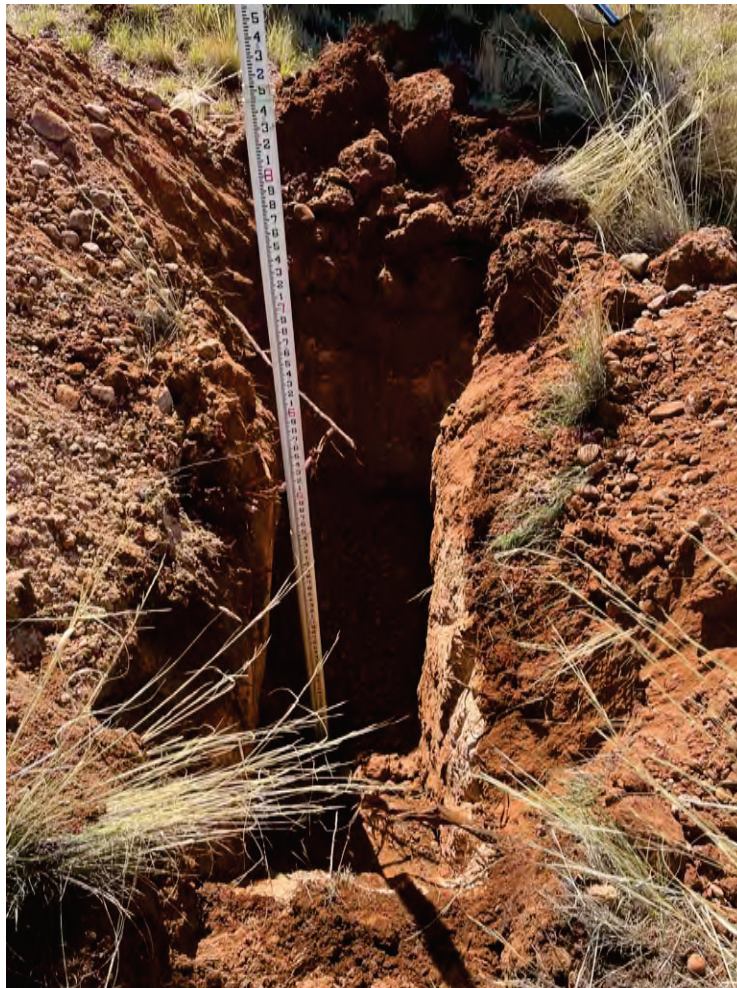
Project Name	Shoulder Improvements	Test Pit	
Project No.	377 008 F0661 01D		
Location	SR 377, MP 10.32	TP-08	
Station, Offset	646+15, 10' R EP		
Lat/Long, elev	34.59263, -110.39474 at 5896'		
Field Engineer	Omied Arianejad	Date	08/14/2024
Field Operator	ADOT Geotechnical Operations	Backhoe	CAT 420

Depth (ft)	Elevation (ft)	Graphic Log	Sample Type	Visual Classification	Lab			
					% Gravel	% Sand	% Fines	Atterberg Limits (LL-PL-P)
1	5895		Bulk	CLAYEY SAND (SC): brown; medium plasticity; no cementation; damp. 2.0	1	52	47	31-16-15
2			Bulk	SANDY LEAN CLAY (CL): light brown to tan; medium plasticity; weak cementation; damp. 4.0	4	46	50	28-15-13
3			Bulk	POORLY GRADED GRAVEL WITH SAND (GP): light brown; non-plastic; no cementation; slightly damp. 5.0	62	34	4	NP
4			Bulk					
5

Stopped test pit excavation at 5'. No groundwater encountered in test pit.

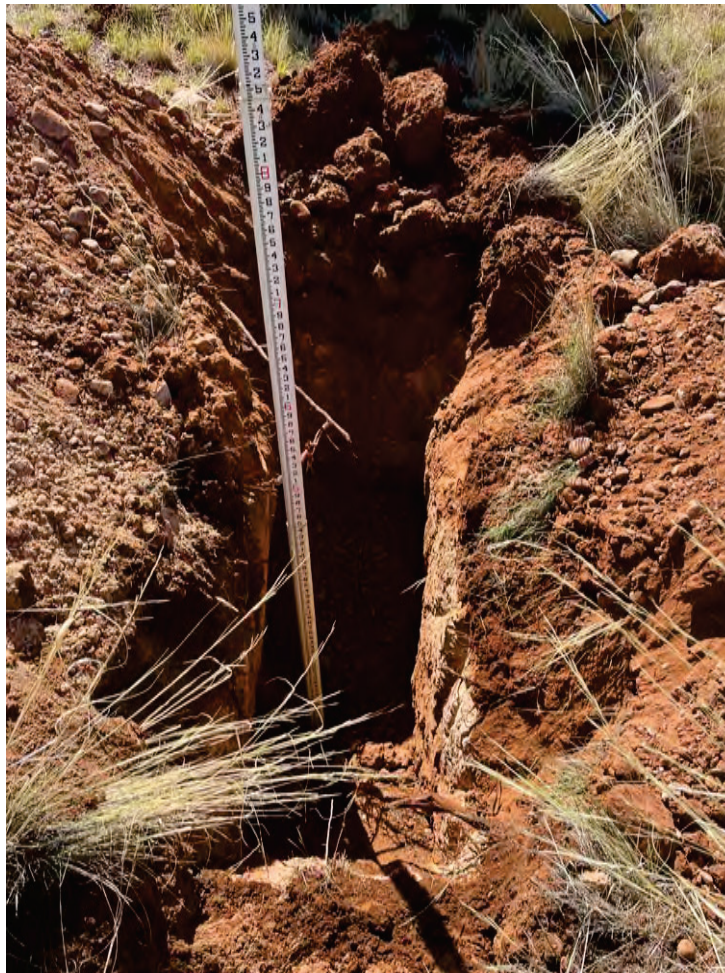
Project Name	Shoulder Improvements	Test Pit	
Project No.	377 008 F0661 01D		
Location	SR 377, MP 10.66	TP-09	
Station, Offset	663+70 10' L EP		
Lat/Long, elev	34.5966, -110.39143 at 5887'		
Field Engineer	Omied Arianejad	Date	08/14/2024
Field Operator	ADOT Geotechnical Operations	Backhoe	CAT 420

Depth (ft)	Elevation (ft)	Graphic Log	Sample Type	Visual Classification	Lab				Samples	
					% Gravel	% Sand	% Fines	Atterberg Limits (LL-PL-P)	In-Situ Moisture Content (%)	In-Situ Dry Density (pcf)
1	5885		Bulk	SILTY, CLAYEY SAND (SC-SM): dark brown to brown; low plasticity; no cementation; damp.	11	67	22	22-16-6	6.4	121
2				2.0						
3				CLAYEY SAND (SC): light brown to tan; medium plasticity; weak cementation; slightly damp.	12	52	36	24-16-8		
4										
5				5.0

Stopped test pit excavation at 5'. No groundwater encountered in test pit.

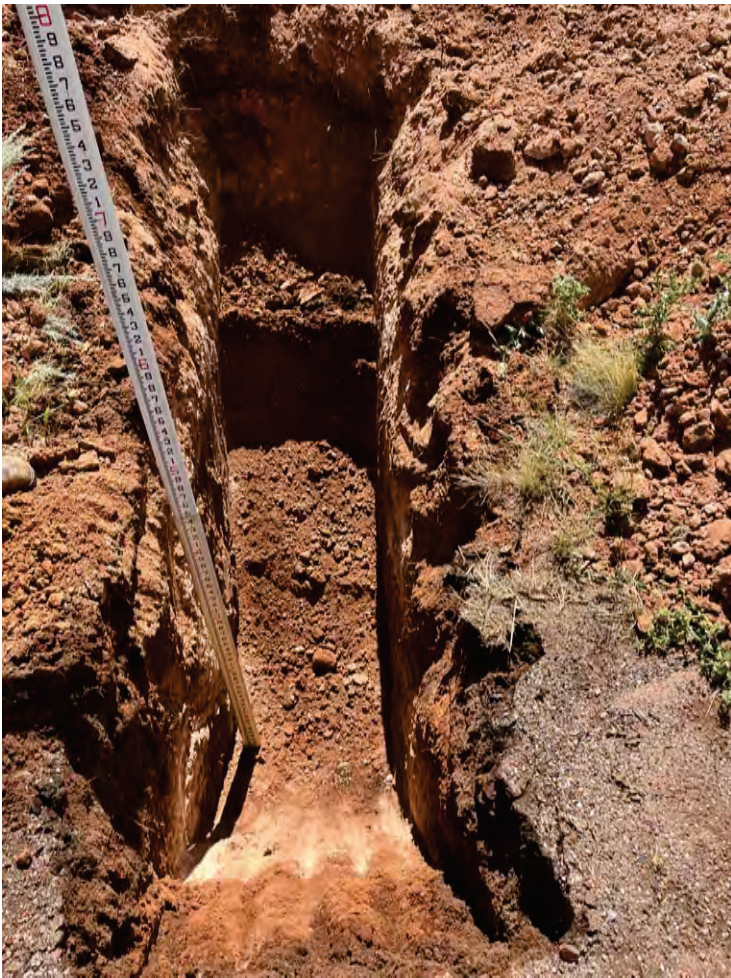
Bulk	CLAYEY SAND WITH GRAVEL (SC): brown to tan; medium plasticity; weak cementation; slightly damp.	17	52	31	26-14-12
2								
3								
4								
5

Stopped test pit excavation at 5'. No groundwater encountered in test pit.

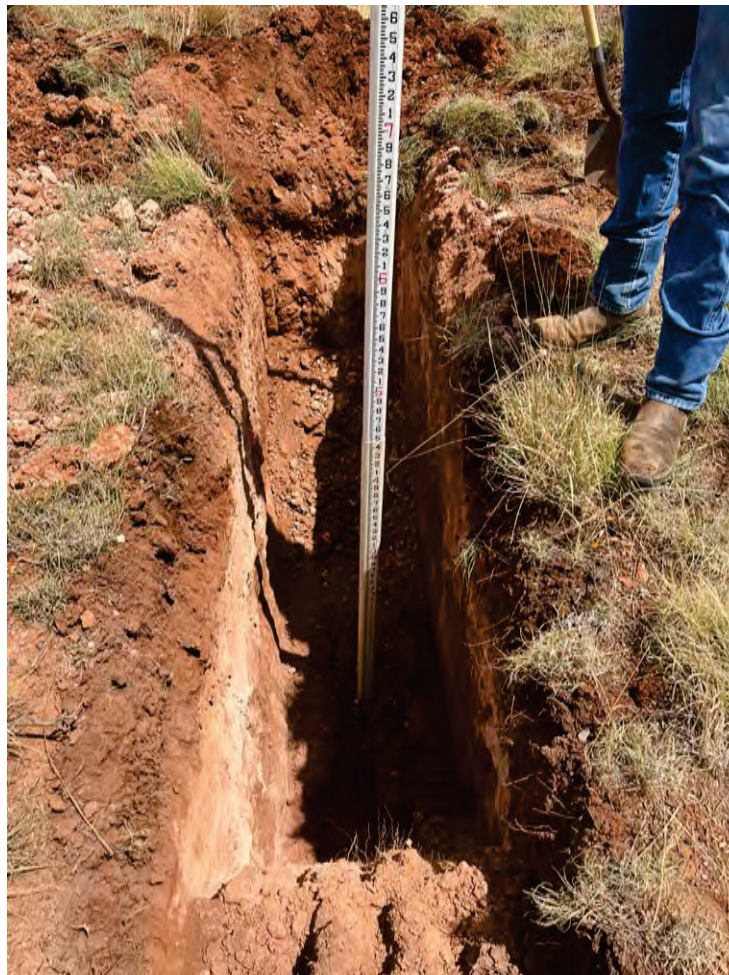
Project Name	Shoulder Improvements	Test Pit	
Project No.	377 008 F0661 01D		
Location	SR 377, MP 11.33	TP-11	
Station, Offset	699+29 5' L EP		
Lat/Long, elev	34.60453, -110.38452 at 5866'		
Field Engineer	Omied Arianejad	Date	08/14/2024
Field Operator	ADOT Geotechnical Operations	Backhoe	CAT 420

Depth (ft)	Elevation (ft)	Graphic Log	Sample Type	Visual Classification	Lab			
					% Gravel	% Sand	% Fines	Atterberg Limits (LL-PL-P)
1	5865		Bulk	SILTY, CLAYEY SAND WITH GRAVEL (SC-SM): light brown; low plasticity; weak cementation; damp.	19	64	17	21-17-4
2								
3								
4			Bulk	SANDY LEAN CLAY (CL): brown; high plasticity; no cementation; slightly damp.	8	42	50	42-23-19
5

Stopped test pit excavation at 5'. No groundwater encountered in test pit.

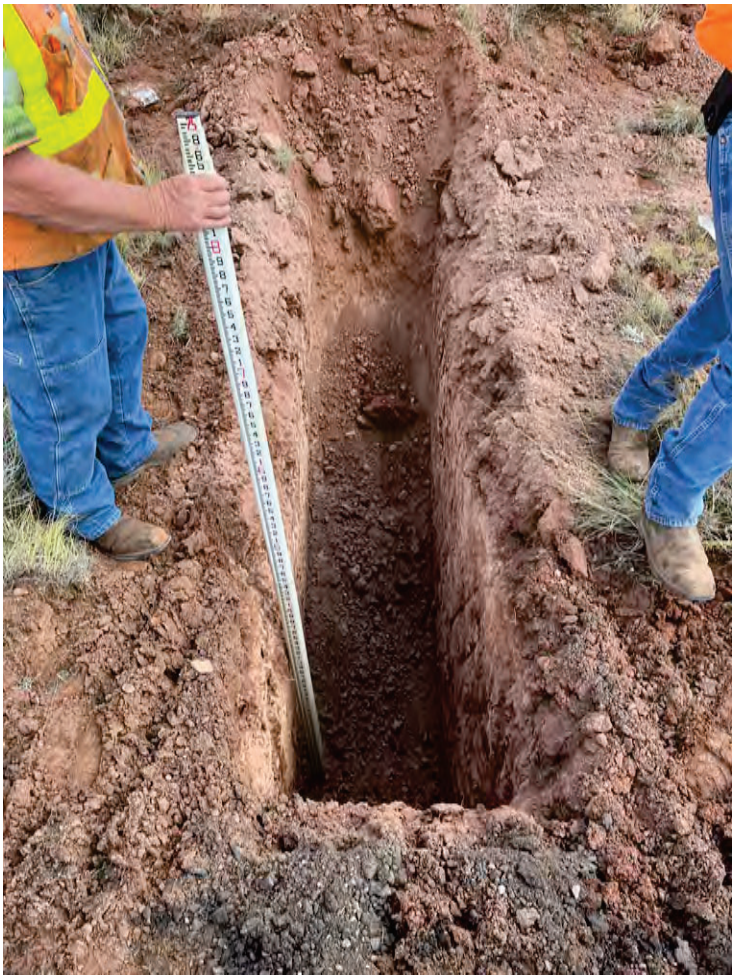
Project Name	Shoulder Improvements	Test Pit	
Project No.	377 008 F0661 01D		
Location	SR 377, MP 11.66	TP-12	
Station, Offset	716+76 5' R EP		
Lat/Long, elev	34.60834, -110.38098 at 5862'		
Field Engineer	Omied Arianejad	Date	08/14/2024
Field Operator	ADOT Geotechnical Operations	Backhoe	CAT 420

Depth (ft)	Elevation (ft)	Graphic Log	Sample Type	Visual Classification	Lab				Samples	
					% Gravel	% Sand	% Fines	Atterberg Limits (LL-PL-P)	In-Situ Moisture Content (%)	In-Situ Dry Density (pcf)
1	5860		Bulk	LEAN CLAY WITH SAND (CL): light brown; high plasticity; weak cementation; slightly damp.	1	24	75	38-18-20	5.3	115.8
2										
3										
4			Bulk	LEAN CLAY (CL): red brown; high plasticity; no cementation; damp.	0	15	85	42-17-25		
5

Stopped test pit excavation at 5'. No groundwater encountered in test pit.

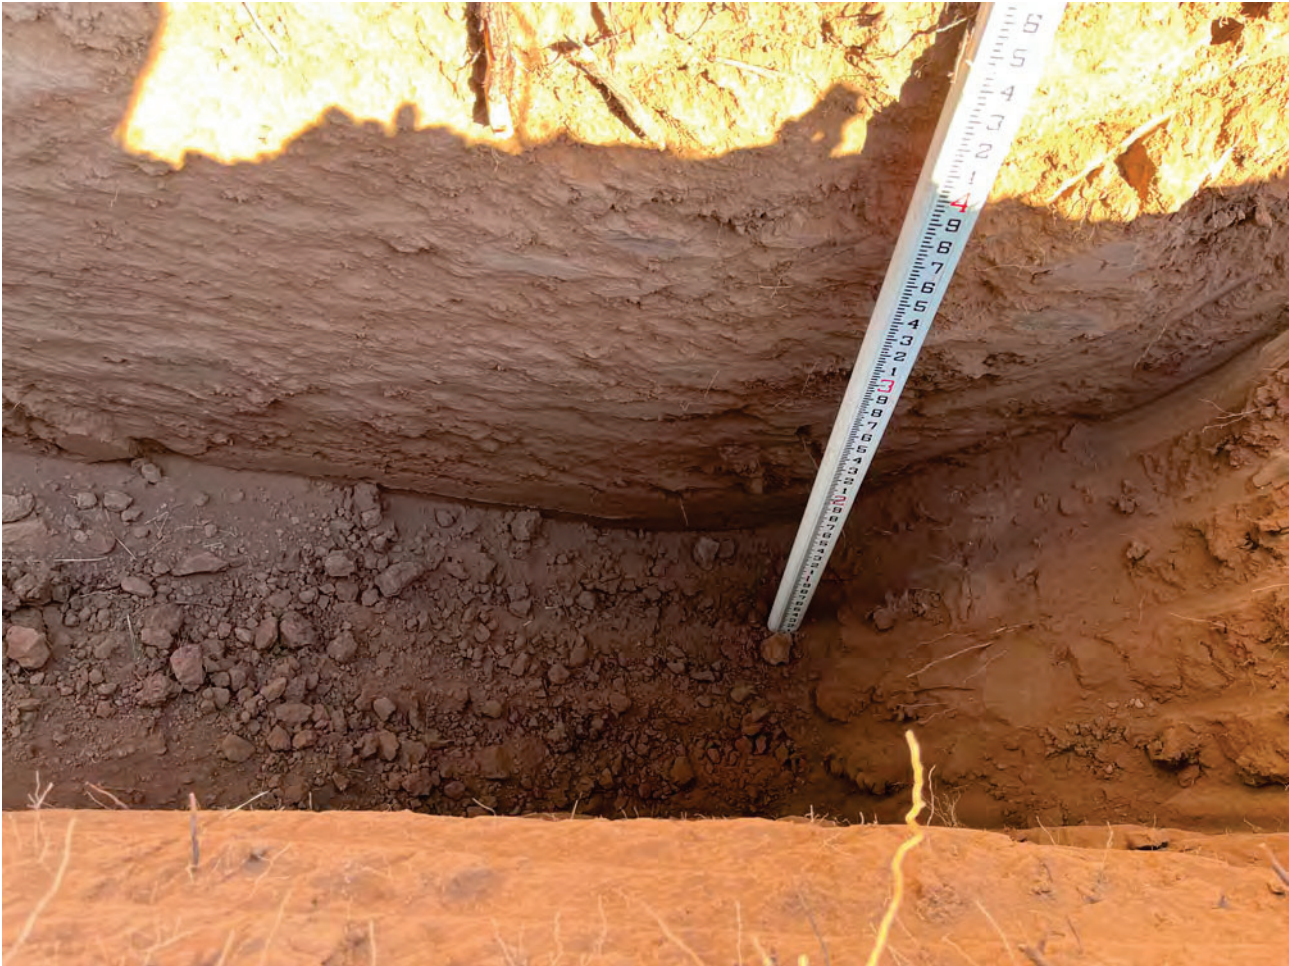
LEAN CLAY (CL): brown; high plasticity; no cementation; slightly damp.				
2								
3								
4								
5

Stopped test pit excavation at 5'. No groundwater encountered in test pit.

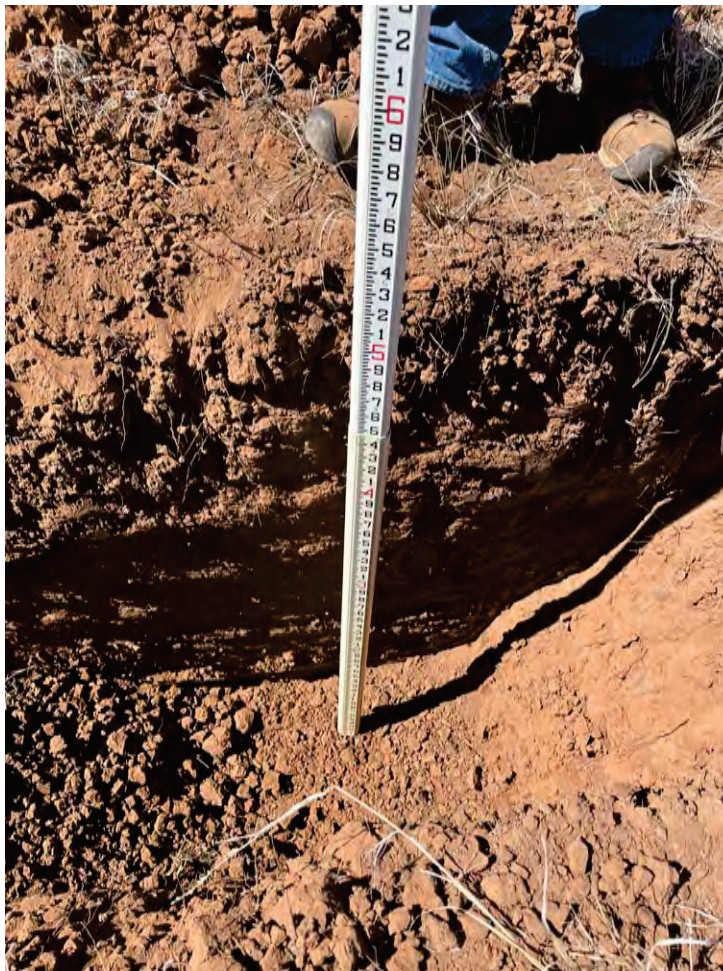
Project Name	Shoulder Improvements	Test Pit	
Project No.	377 008 F0661 01D		
Location	SR 377, MP 12.32	TP-14	
Station, Offset	752+08, 10' R EP		
Lat/Long, elev	34.61620, -110.37410 at 5843'		
Field Engineer	Omied Arianejad	Date	08/20/2024
Field Operator	ADOT Geotechnical Operations	Backhoe	CAT 420

Depth (ft)	Elevation (ft)	Graphic Log	Sample Type	Visual Classification	Lab			
					% Gravel	% Sand	% Fines	Atterberg Limits (LL-PL-P)
1	5840		Bulk	LEAN CLAY (CL): brown; high plasticity; no cementation; slightly damp.	0	13	87	43-19-24
2								
3								
4								
5

Stopped test pit excavation at 5'. No groundwater encountered in test pit.

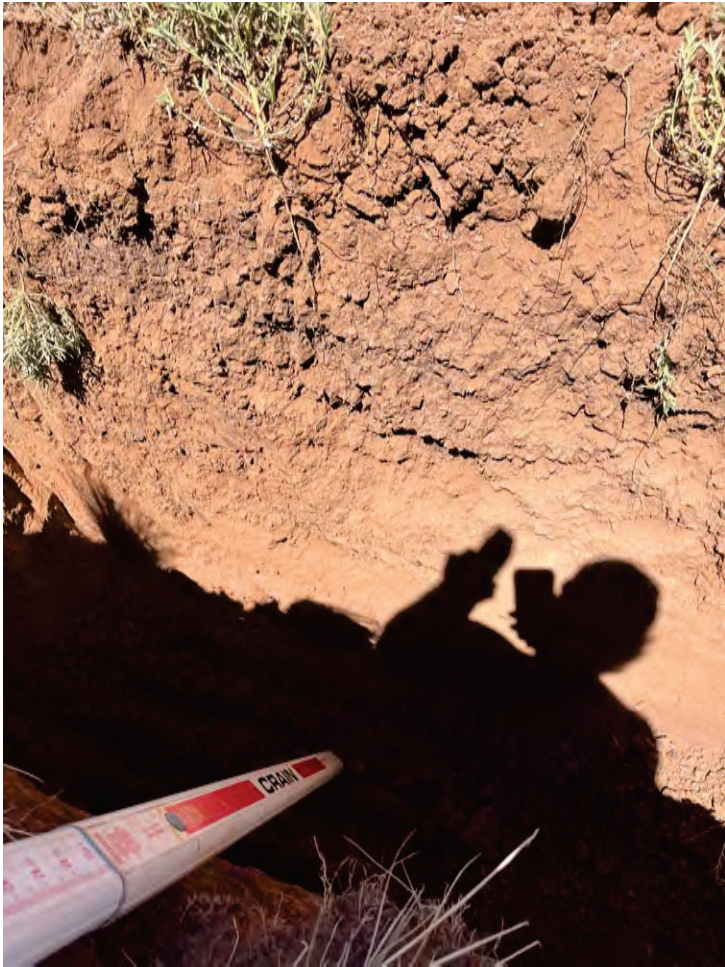
Bulk	SANDY LEAN CLAY (CL): dark brown to brown; high plasticity; no cementation; slightly damp.	8	28	64	35-17-18	6.7	96.6
2										
3										
4										
5

Stopped test pit excavation at 5'. No groundwater encountered in test pit.

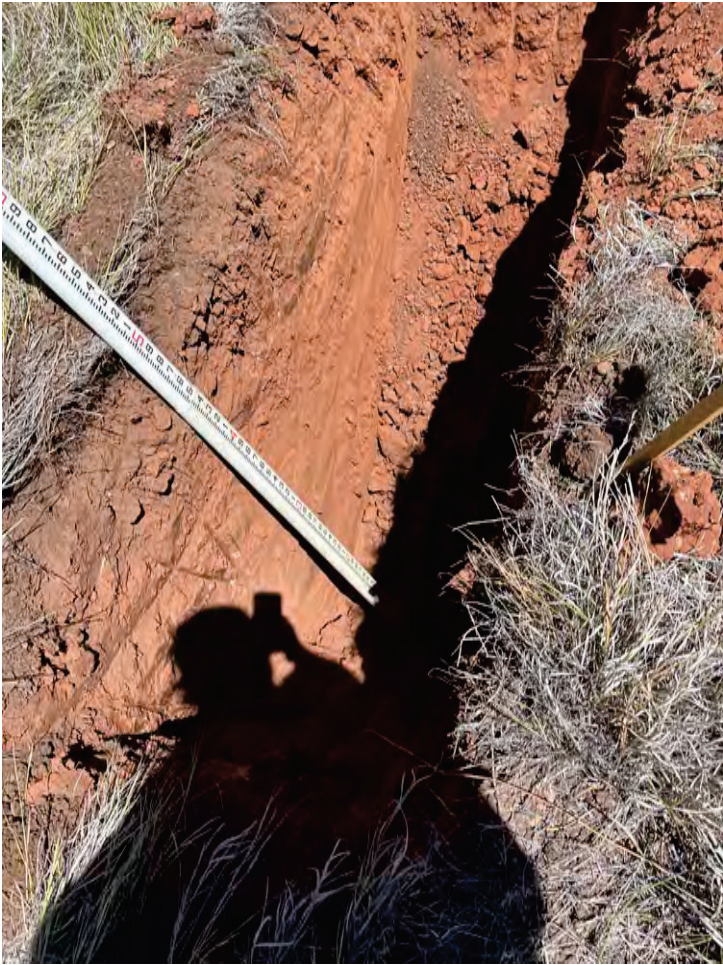
Bulk	SANDY LEAN CLAY (CL): dark brown to brown; medium plasticity; no cementation; slightly damp.	0	48	52	27-13-14
2								
3								
4								
5

Stopped test pit excavation at 5'. No groundwater encountered in test pit.

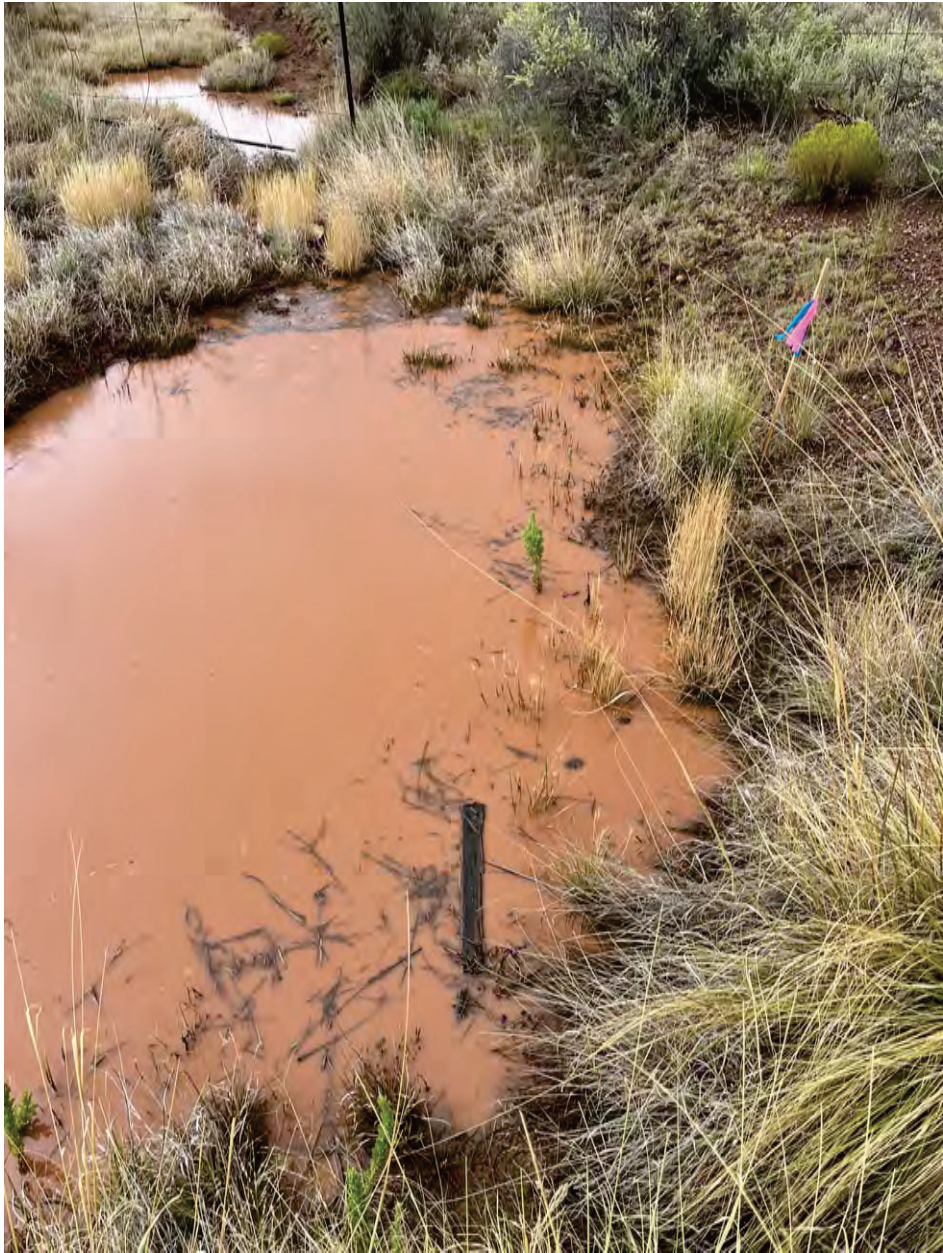
Hand	CLAYEY SAND (SC): brown; medium plasticity; no cementation; damp. 1.0	11	40	49	24-13-11

Stopped test pit excavation at 1'. No groundwater encountered in test pit.

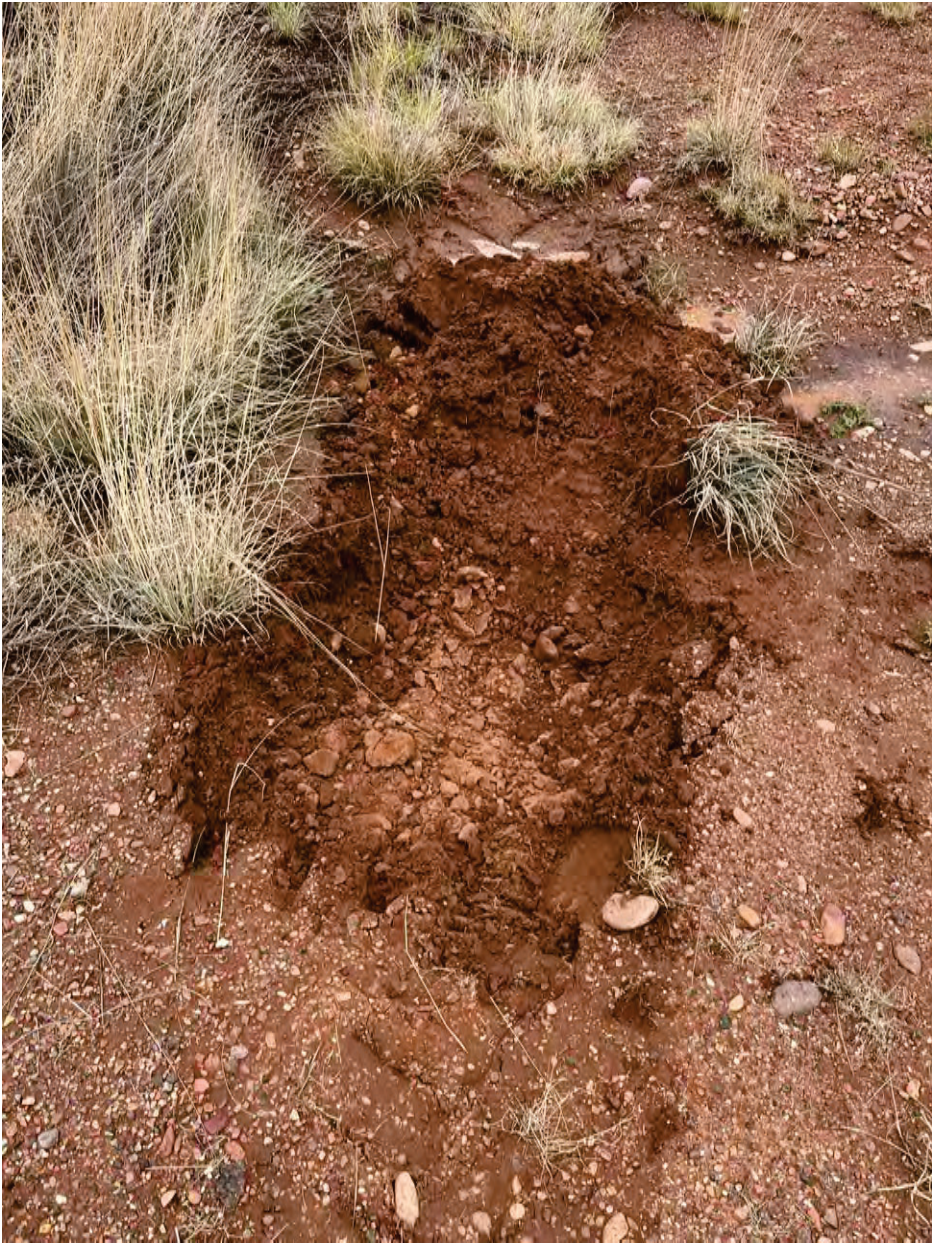
Hand	CLAYEY SAND WITH GRAVEL (SC): brown; medium plasticity; no cementation; slightly damp. 1.0	20	49	31	22-13-9

Stopped test pit excavation at 1'. No groundwater encountered in test pit.

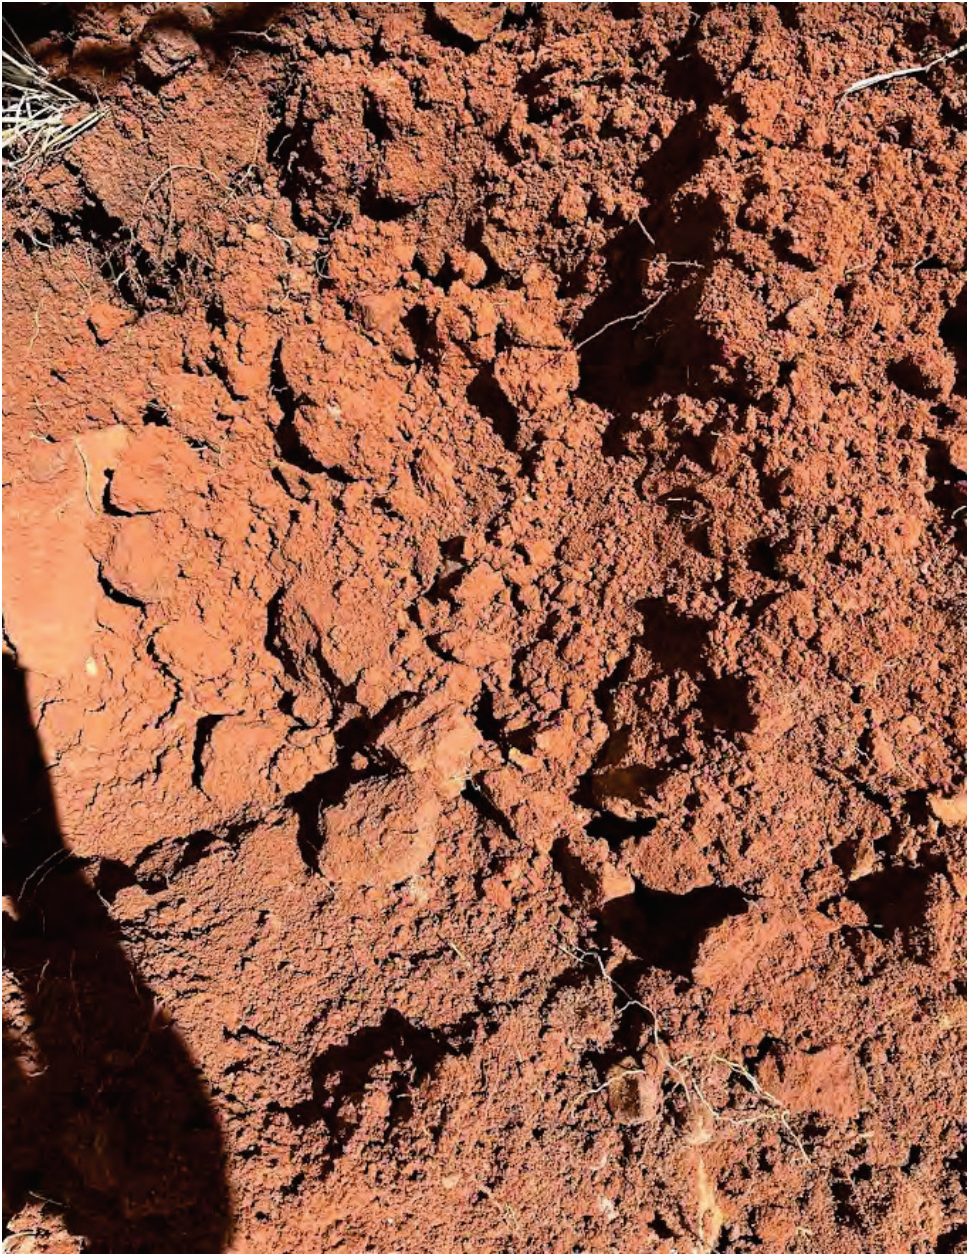
Hand	CLAYEY SAND WITH GRAVEL (SC): brown; medium plasticity; no cementation; damp. 1.0	20	56	24	31-17-14

Stopped test pit excavation at 1'. No groundwater encountered in test pit.

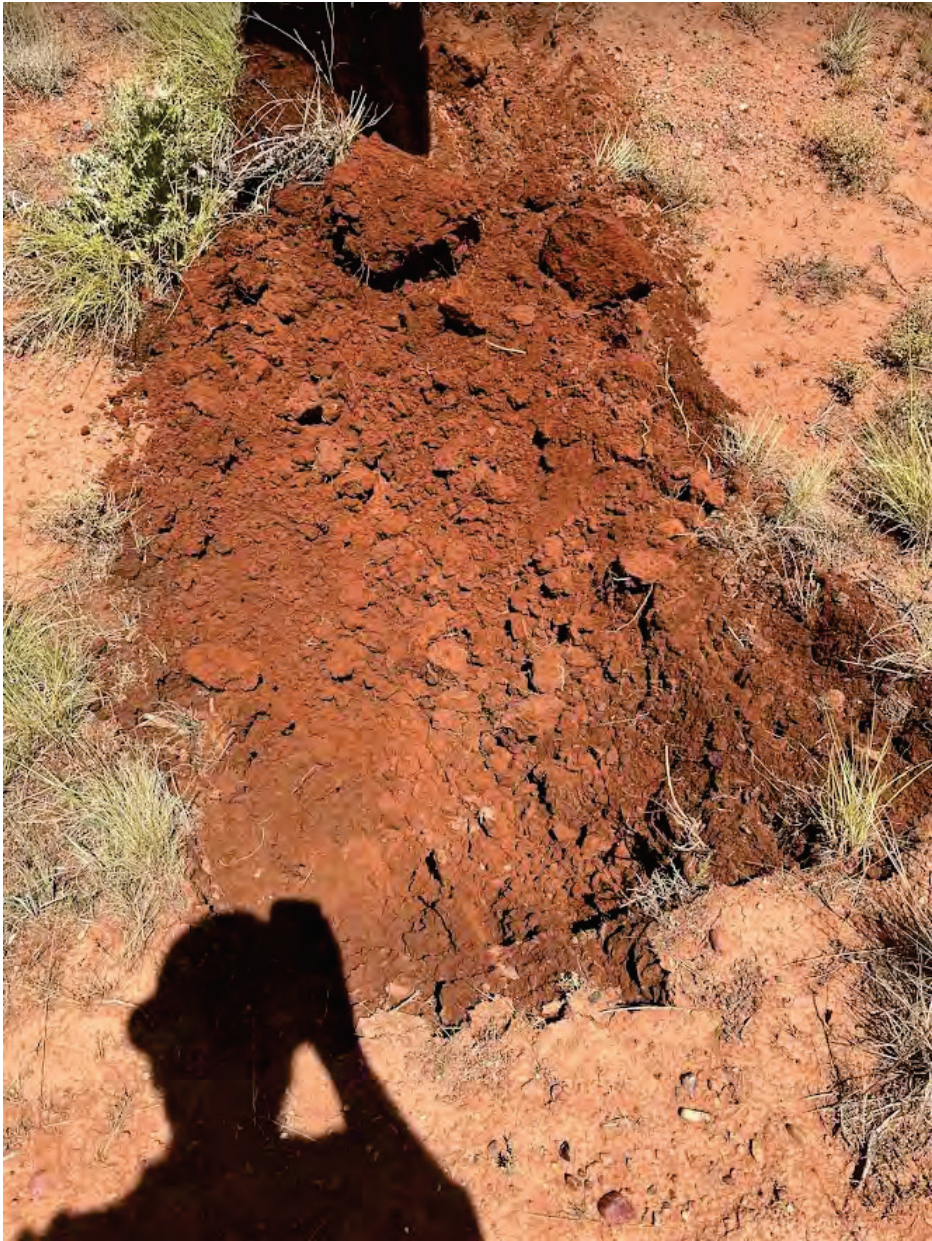
Hand	CLAYEY SAND (SC): red brown to brown; medium plasticity; no cementation; slightly damp. 1.0	5	53	42	27-15-12

Stopped test pit excavation at 1'. No groundwater encountered in test pit.
