GEOTECHNICAL REPORT**ADOT Project No. 377 NA 008 F0661 01D****Federal Reference Project No. FA-377-A(203)T****MP8 - Phoenix Park Wash, S of Dry Lake**

Subject:
Geotechnical Report
MP8 - Phoenix Park Wash, S of Dry Lake
ADOT Project No. 377 NA 008 F0661 01D

This report presents the results of our geotechnical engineering services to support the construction of the shoulder widening on State Route 377 (SR-377) at mileposts (MP) 8 to MP 13. The project is located north of the community of Heber-Overgaard within the Arizona Department of Transportation (ADOT) Northeast District.

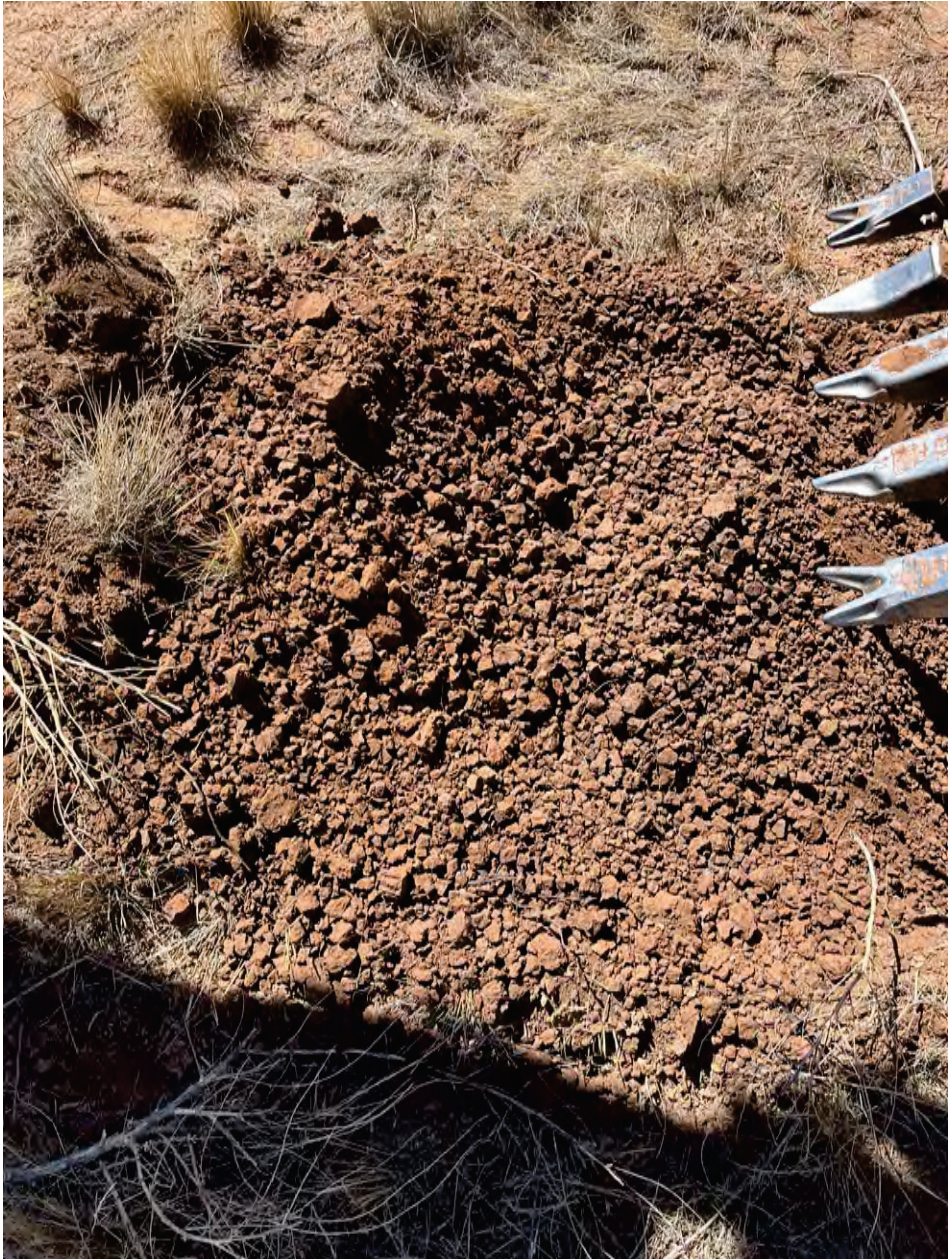
Hand	LEAN CLAY WITH SAND (CL): dark brown to brown; medium plasticity; no cementation; slightly damp. 1.0	0	27	73	33-18-15

Stopped test pit excavation at 1'. No groundwater encountered in test pit.
