# TT0561 – Olive Avenue Roadway Improvements Geotechnical and Pavement Design Report

MCDOT Project No.: TT0561; Contract No.: CY 2023-014

November 3, 2025 | Terracon Project No. CP255023

Re: Geotechnical and Pavement Design Report  
TT0561 – Olive Avenue Roadway Improvements  
Between State Route (SR) 303L and Reems Road  
Waddell/Glendale, Maricopa County, Arizona  
Terracon Project No. CP255023

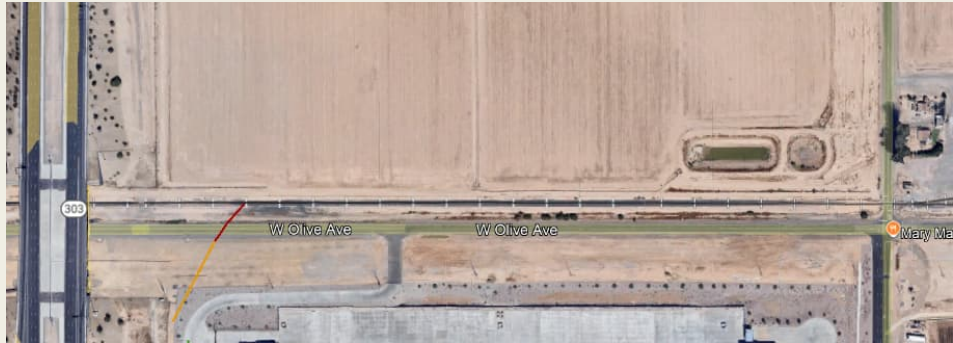
Item	Description
Current Ground Cover	The ground cover across the site generally consists of asphalt concrete paved roadways followed by graded shoulders and generally followed by agricultural land or industrial/commercial developments.
Existing Topography	The project site is relatively flat. Based on the roadway elevations outlined in the Plans (and review of Google Earth Pro imagery), the west end of the Olive Avenue project (at approx. SR303L) has an elevation of approximately 1,167 feet above mean sea level (amsl), and the east end of the Olive Avenue project (at approx. Reems Road) has an elevation of approximately 1,127 feet amsl. This elevation change generally takes place gradually across the project site.
Photography Log	A photography log of selected photographs from the site is included in this report and shows typical site conditions.
Geological Hazards	<p>The alignment of Olive Avenue crosses a confirmed continuous and discontinuous earth fissure mapped by the Arizona Geological Survey (AZGS) at approximately 425 feet (according to measurements obtained from Google Earth Pro) east of SR303L. Terracon previously evaluated this earth fissure further south as part of a previous project for SR303L improvements for the Arizona Department of Transportation (ADOT). The approximate location of the mapped confirmed and discontinuous earth fissure is shown in the image below (red and orange line).</p>

Portions of the Western Metropolitan Phoenix area have experienced historic and documented groundwater decline. The depletion of the groundwater table has resulted in compression of the aquifer material and the phenomenon known as areal subsidence. Earth fissures are fractures or cracks that form in alluvial basins due to substantial groundwater overdrafts that produce local subsidence. Earth fissures develop within land subsidence areas where a significant thickness of compressible alluvium overlies shallow irregular bedrock surfaces such as ridges and fault scarps or other subsurface features. As previously mentioned, the project alignment of Olive Avenue crosses a confirmed continuous and discontinuous earth fissure mapped by the AZGS at approximately 425 feet east of SR303L. The approximate location of the mapped confirmed and discontinuous earth fissure is shown in the image below (red and orange line)<sup>5</sup>(AZGS, 2019):

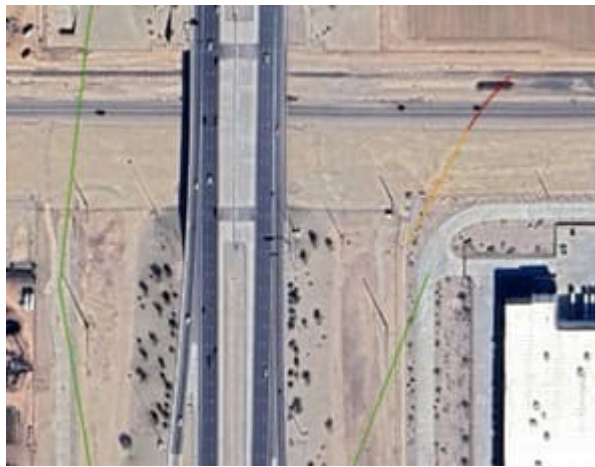
Google Earth Pro, 2025

There are several difficulties with a lineament study when trying to identify unconfirmed earth fissures, particularly when the earth fissures cross agricultural fields that are plowed on a regular basis or when the native land is developed, and aerial photographs are not taken on a routine schedule. The following selected aerial photographs are provided to summarize our delineation show the process of identifying lineations. Red dots have been included on the aerial photographs to outline the lineation along the mapped earth fissure.

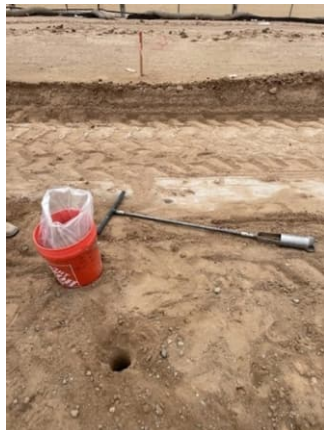
Boring R-106, Overhead Utility, Hand Auger

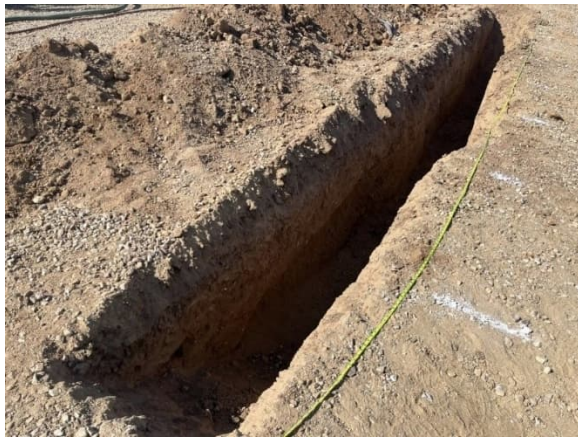
Earth Fissure Trench 2

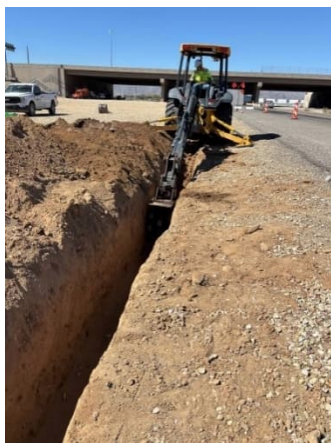
Typical, Backfill Compaction

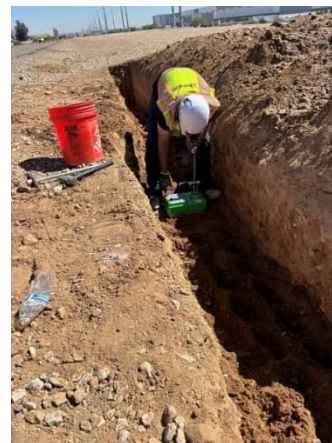
Typical, Nuclear Density Testing

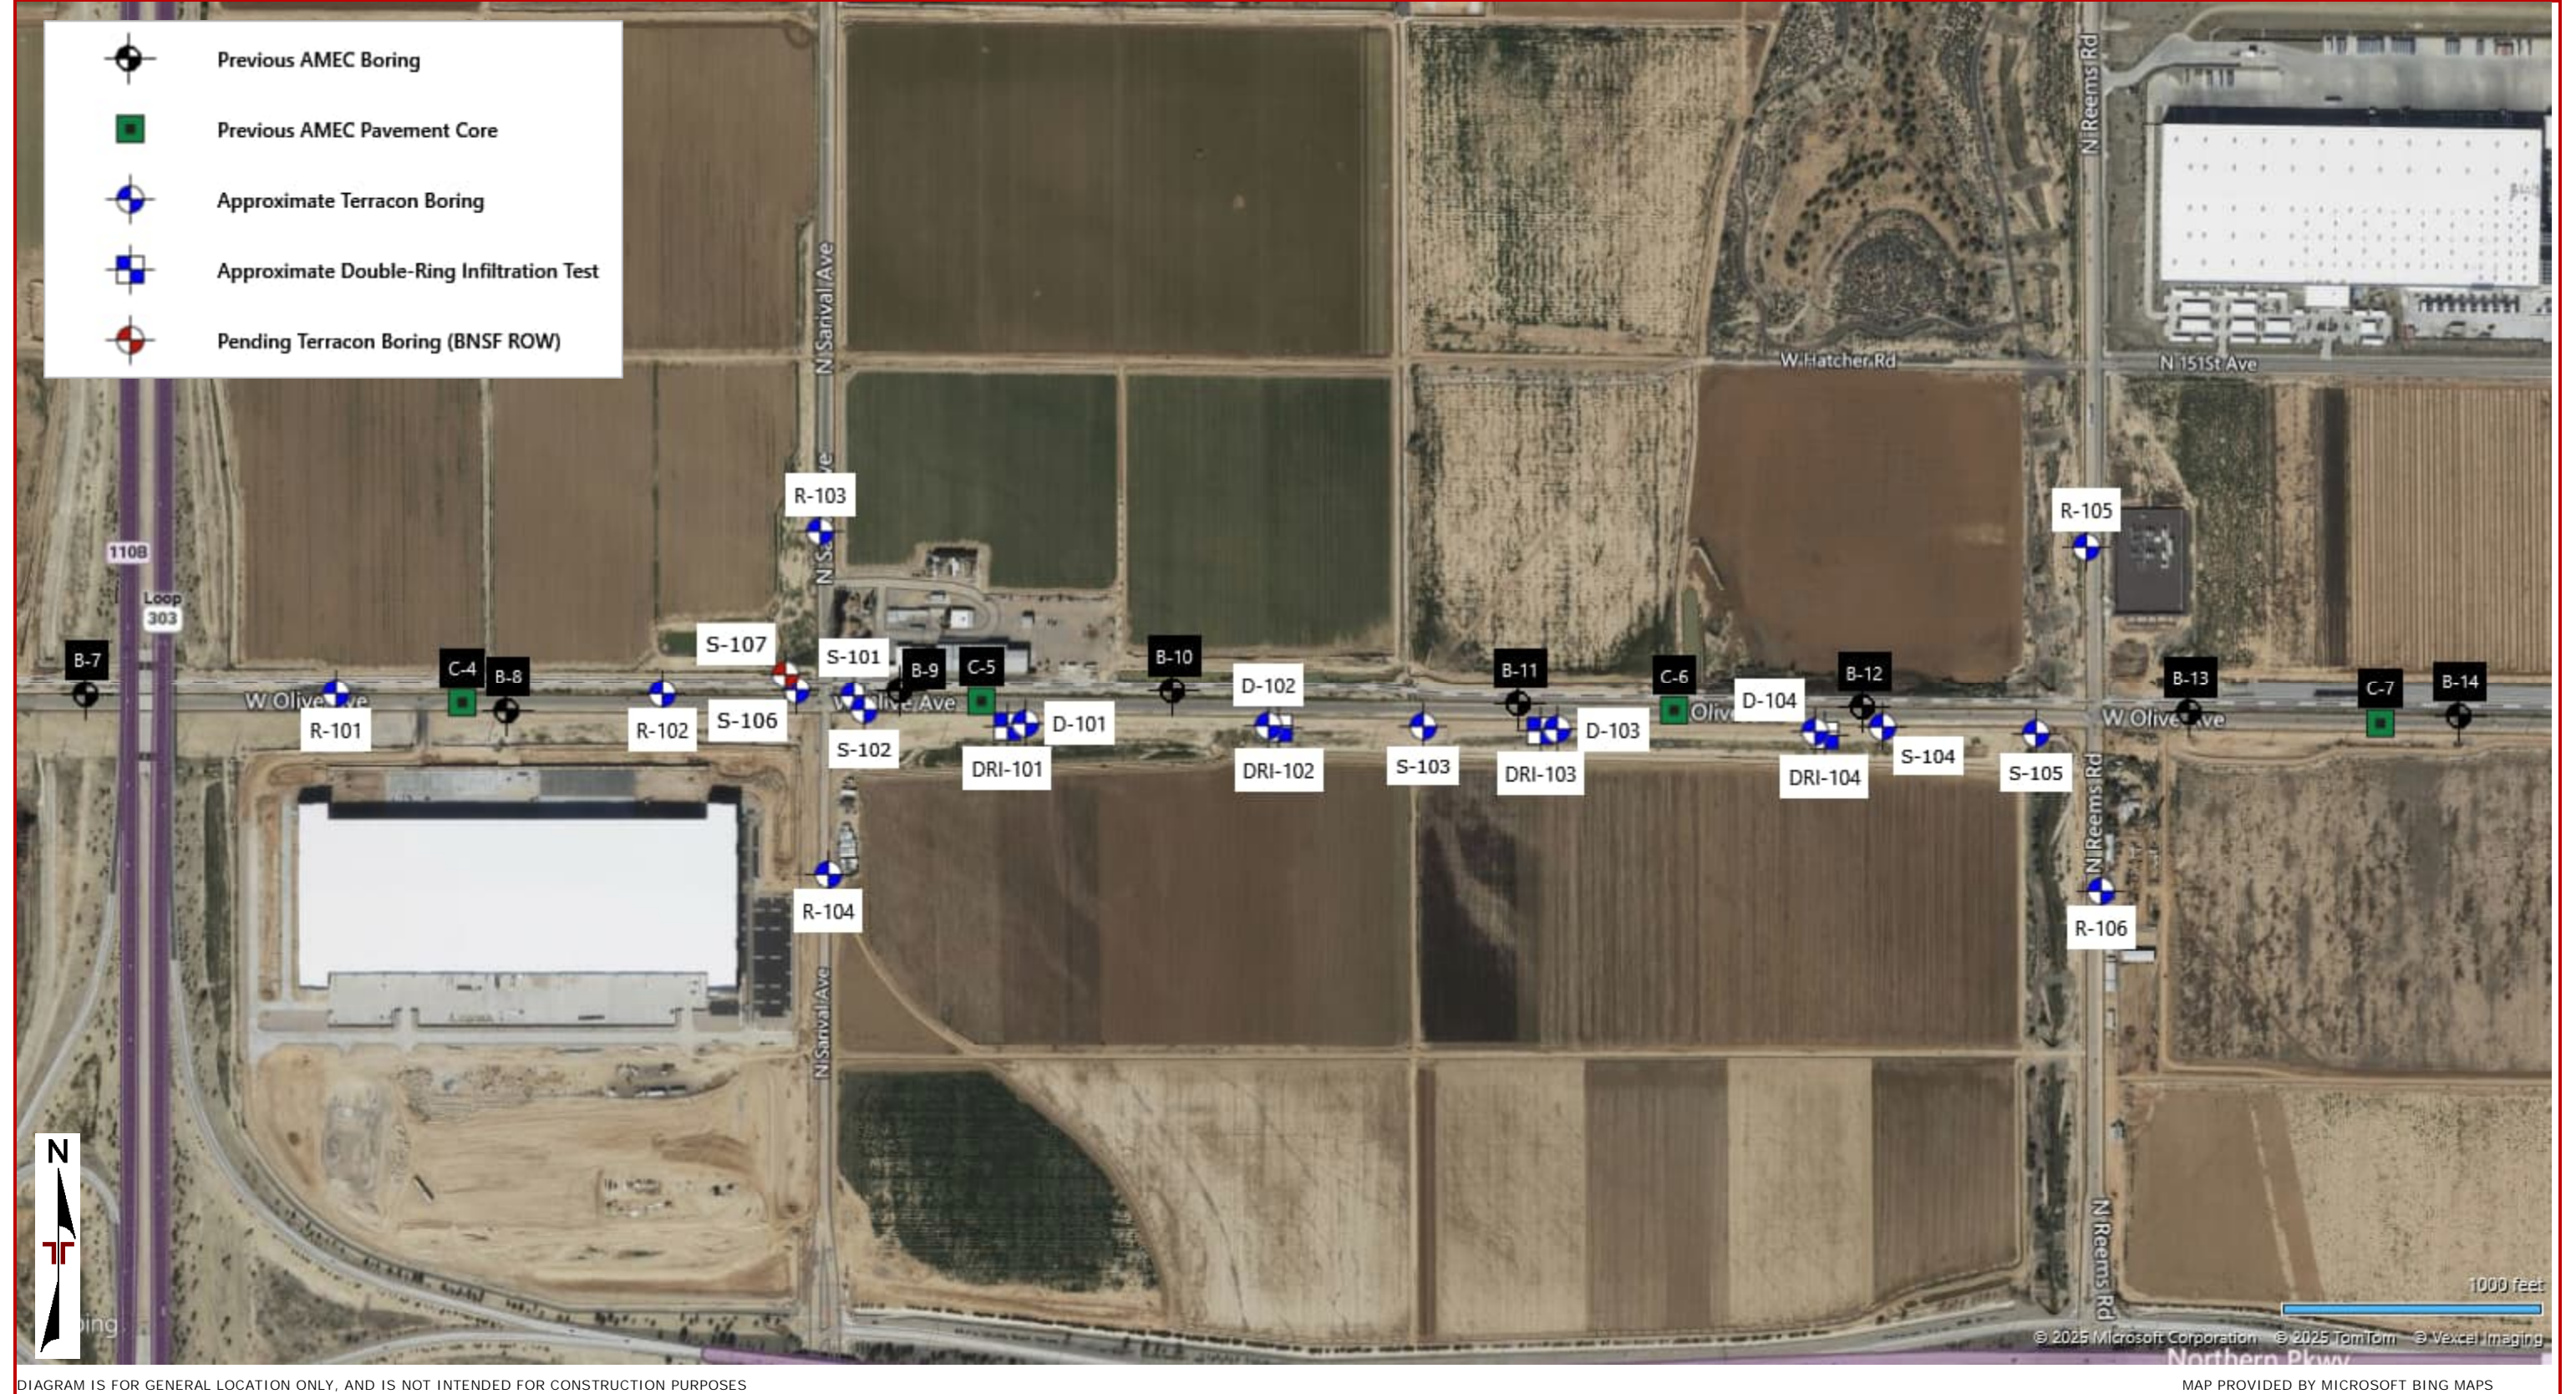
### Exploration Plan

Our geotechnical engineering scope of work for this project also included performing laboratory testing, geotechnical and pavement engineering analysis, and preparation of this report. Maps showing the site and boring/infiltration testing locations are shown on the [Site Location](#) and [Exploration Plan](#), respectively. The boring logs and the results of the laboratory testing performed on soil samples obtained from the site during our field exploration are included in the [Exploration Results](#) section.
