# Geotechnical Engineering Report

**Sedona Airport Infield Drainage Improvements  
235 Air Terminal Drive  
Sedona, Arizona**

May 4, 2021  
Terracon Project No. 65205270

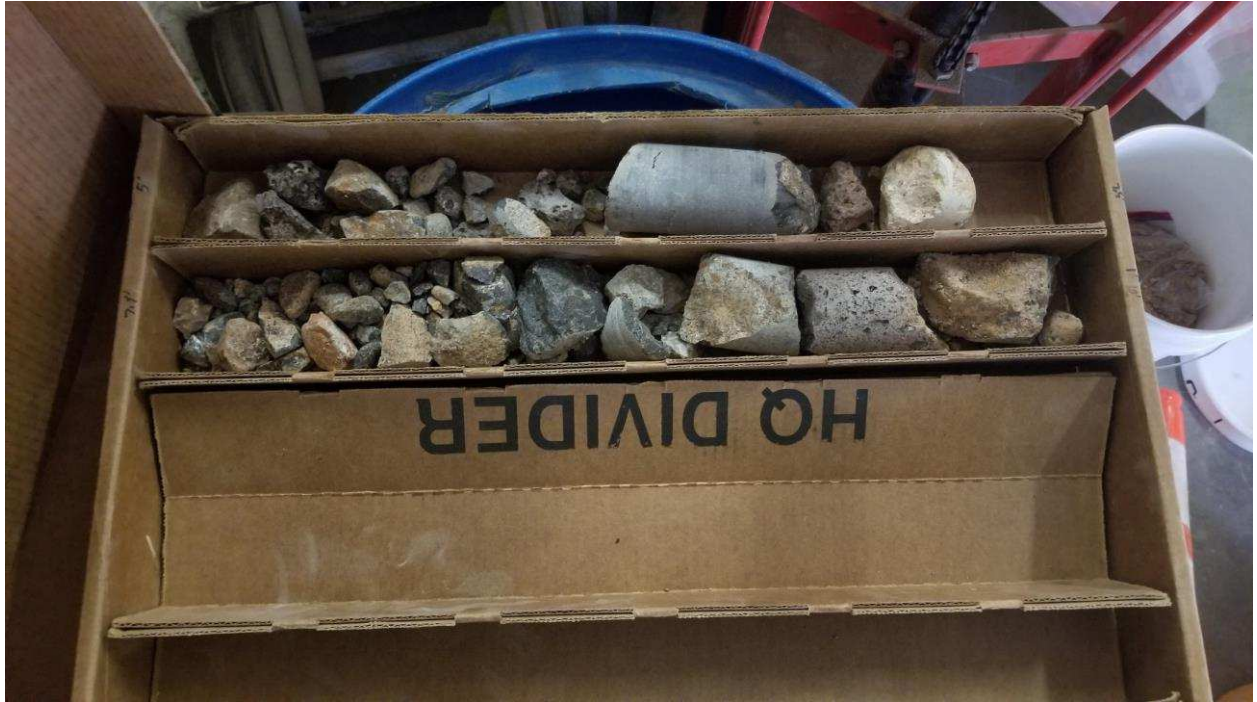
Photo 1 Rock Core in Boring B-3
