**PHOENIX DEER VALLEY AIRPORT**  
**DVT RELOCATE TAXIWAY BRAVO**  
**AND CONSTRUCT CONNECTORS B6 AND B9 – GMP 4**  
**AV31000092 FAA**

**ENGINEER'S DESIGN REPORT**

**JULY 20, 2026**

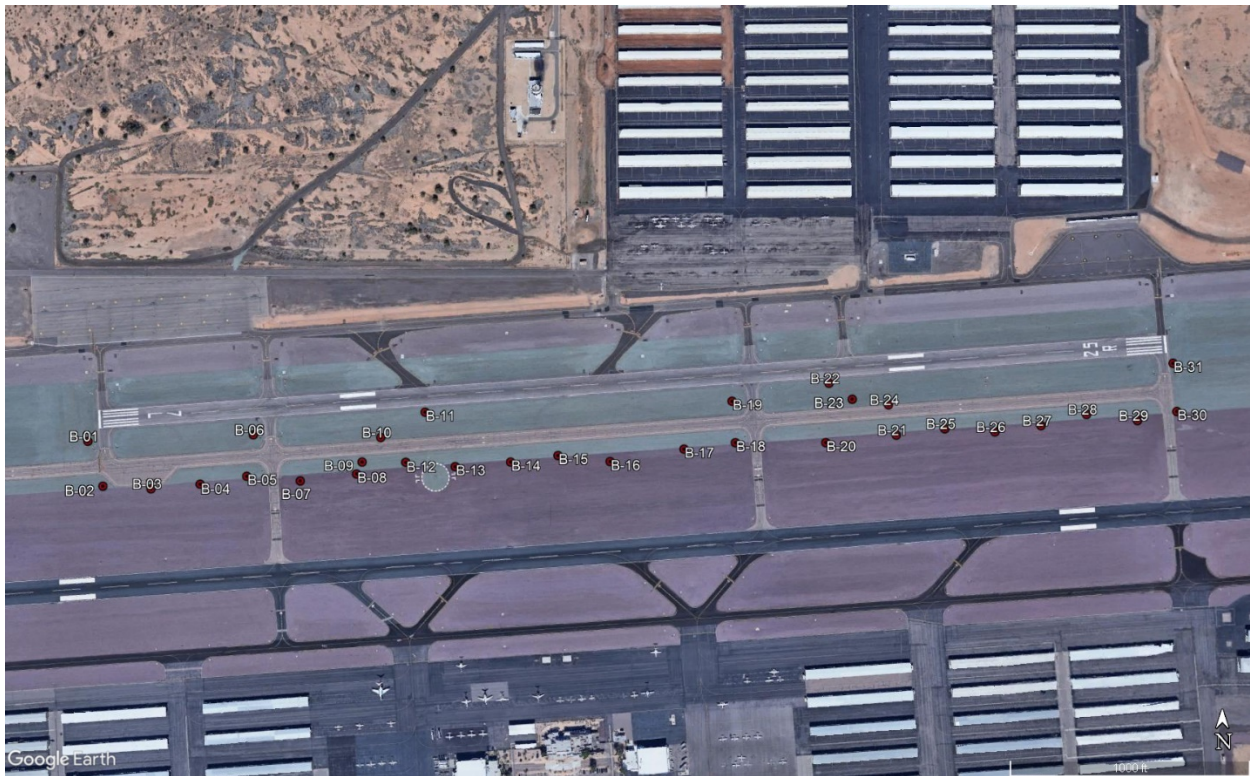
## **APPENDIX A: SITE MAP AND SAMPLE LOCATIONS**

**Boring Location**

The recommendations found within this report are based upon our field investigation of the site, which occurred on September 3, 4, & 5, 2019. Subsurface soil samples were taken from borings completed at the locations shown in Appendix A of this report.
